Beneficial Home Inspections

Your Home Inspection Report

PROPERTY INSPECTION REPORT

Concerning: 1111 Sample Street, Sample, TX
(Address or Other Identification of Inspected Property)

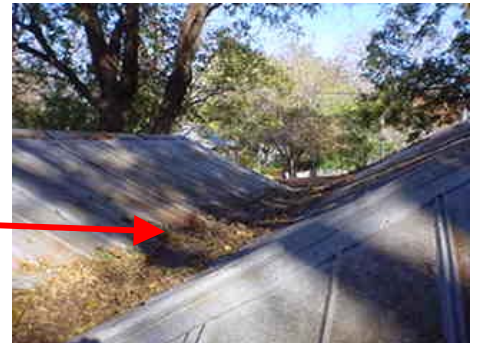
The garage addition to the house still has lead headed nails that secure the sheet metal roofing. This is currently leaking and at minimum I recommend the replacement of all nails with neoprene washer screws. Although this will not eliminate the problem of leaks, it will help minimize the problem.

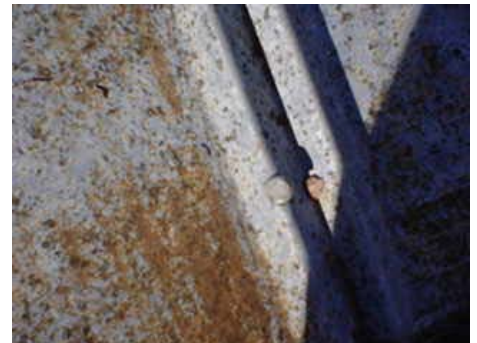
The design of the roofing system is such that several vulnerable areas exist.

My recommendation is for a new roof design to eliminate the dead valley areas and the replacement of the current screw down roof with a new standing seam metal roof or a asphalt shingle system.

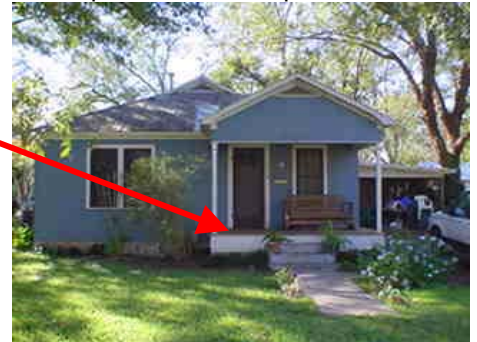
As there is a danger of falling, a railing should be provided for the porch. For improved safety, it is recommended that a railing be provided for the steps at the front entrance to the house.

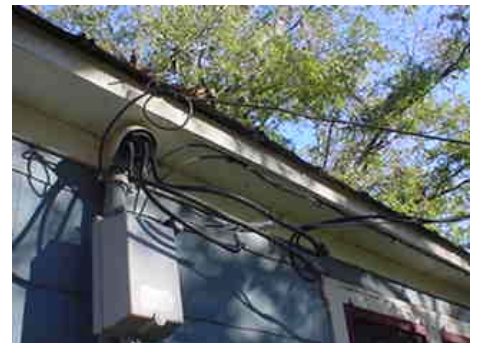
The service wires do not have adequate clearance from the ground and should be repaired. The top of the service mast and the service wires should be at least fifteen (15) feet from the ground.

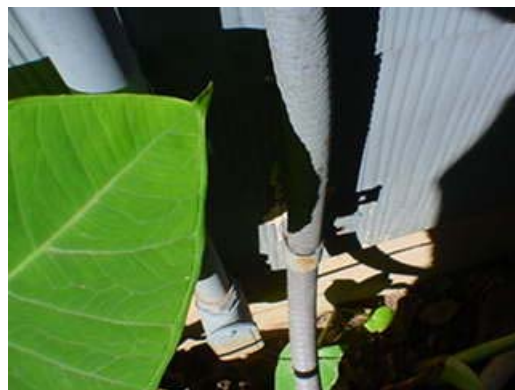
Have qualified licensed electrician verify the safe installation of the proper size breaker for unit rating.

Electrical line conduit loose / should be secured

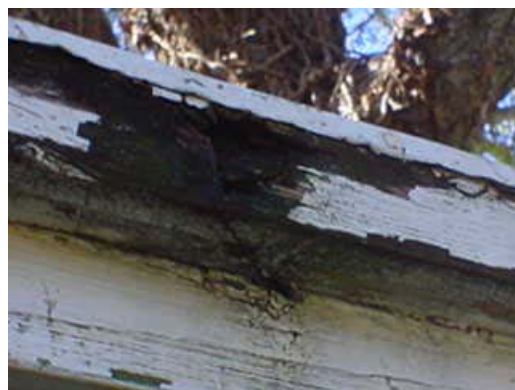
Water damage to drip edge

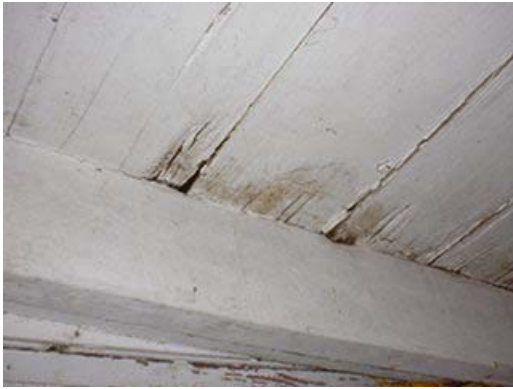
Water damage to decking located on flat roof over carport.

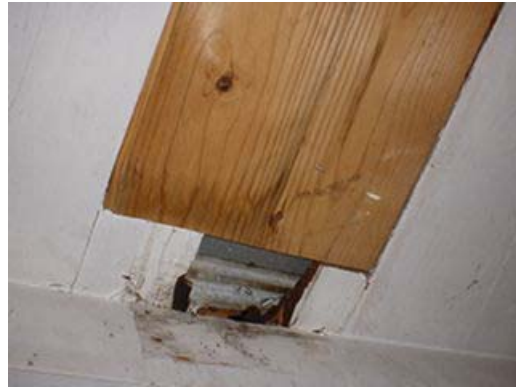
More water damage

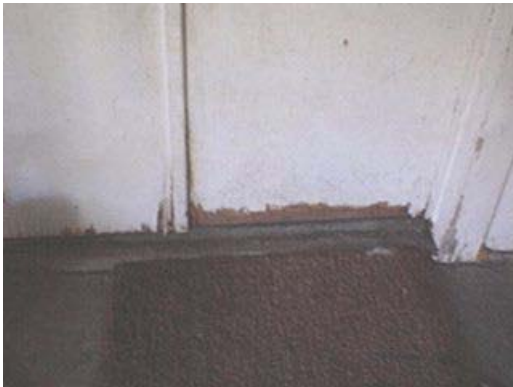
Water damage was observed adjacent to the door in the laundry room. The cause should be determined and repaired to ensure proper operation of the door. Damaged or non-functional doors should be repaired.
(See Picture Page)

Water damage to door from carport area.

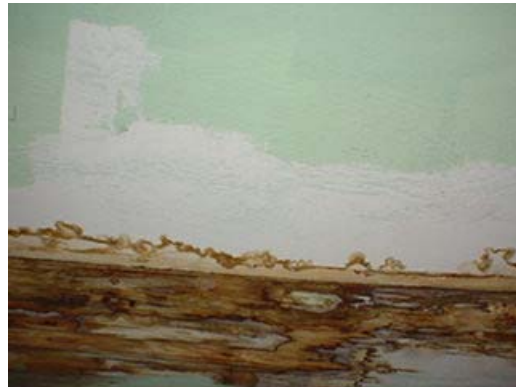
Evidence of several areas that leak by numerous water damage locations throughout the garage, washroom and carport areas.

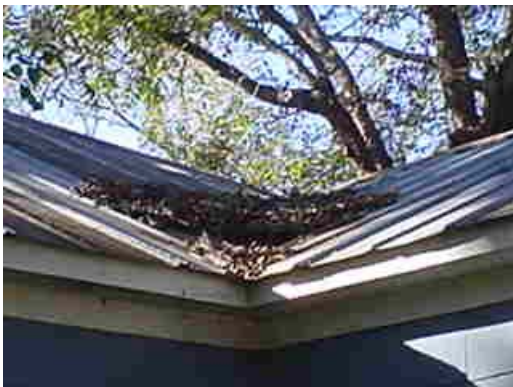
Suspected cause of concern is the two-pitched areas that meets and forms a flat dead valley area, which can collect water.

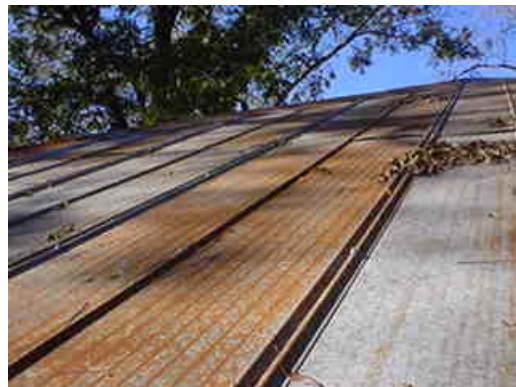
Areas of rusted metal roof material.

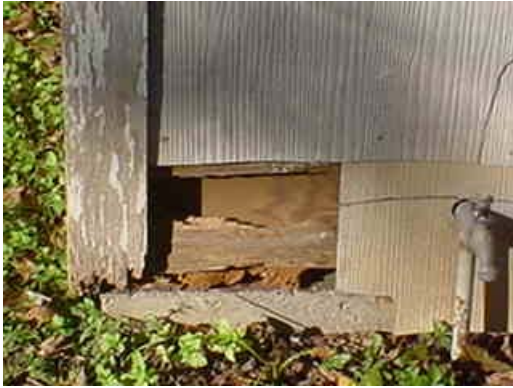
Various damaged areas missing siding and water damage noted.

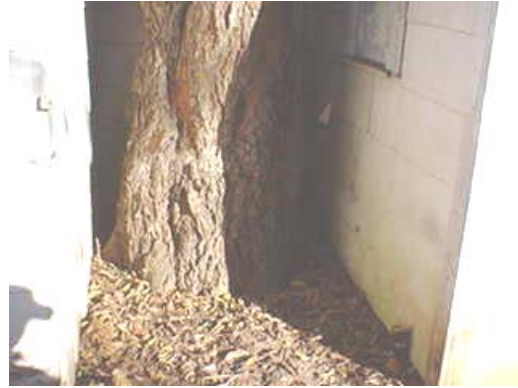
Large tree in close proximity to small foundation

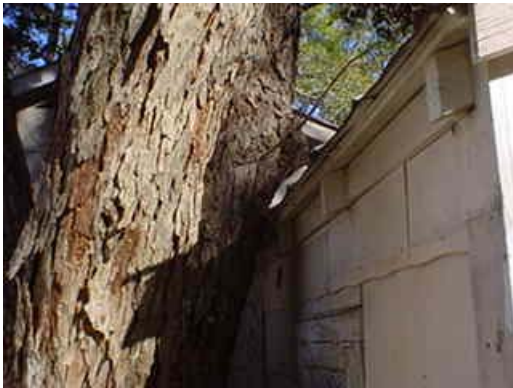
Tree can and will cause damage to roof

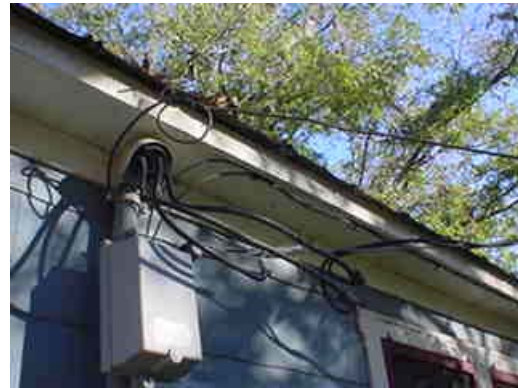
Electrical service wiring entrance too low by today's standards. Should be repaired.

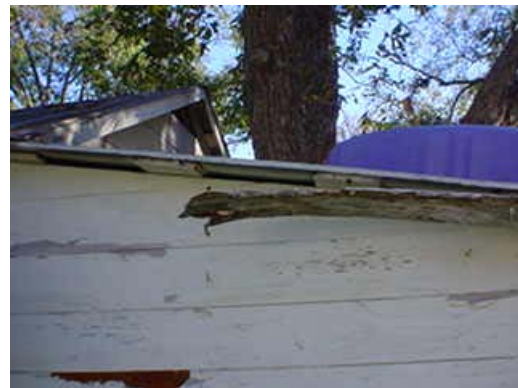
More water damage trim

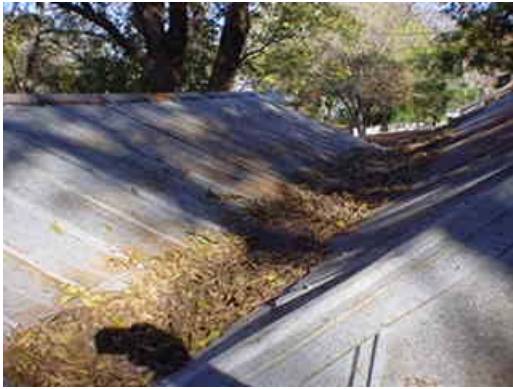
Dead valley area - note that the lead nails were replaced with neoprene washer screws only on the main house roof. The garage still has the lead nails, which are currently leaking.

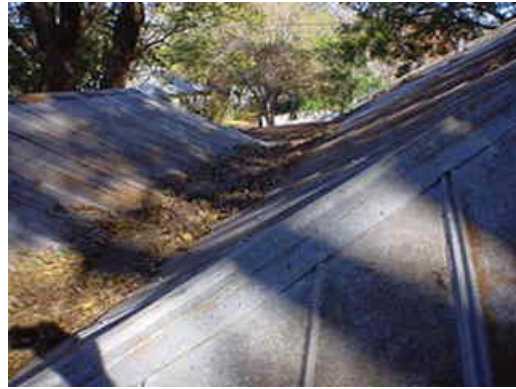
Note how dead valley area collects leaves, which in turn promotes the collection of moisture.

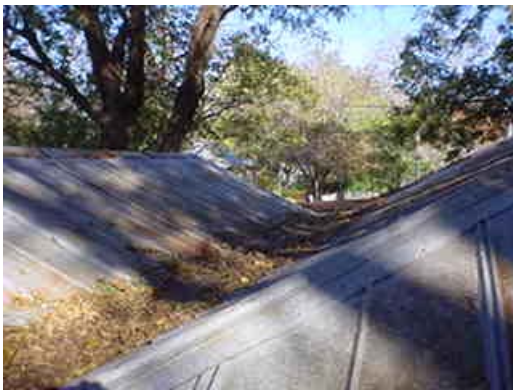
Roofing design vulnerable to roof leaks. Water collects and drains to flat roof over carport. Recommend redesign of roof structure in this area.

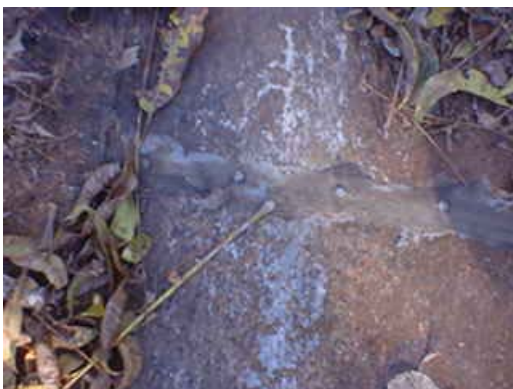
Seam in dead valley area failing. Re-secure nails and re-seal.

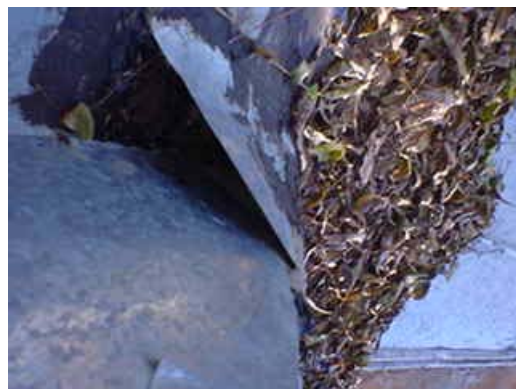
Vulnerable area under flashing detail should be sealed to prevent moisture intrusion.

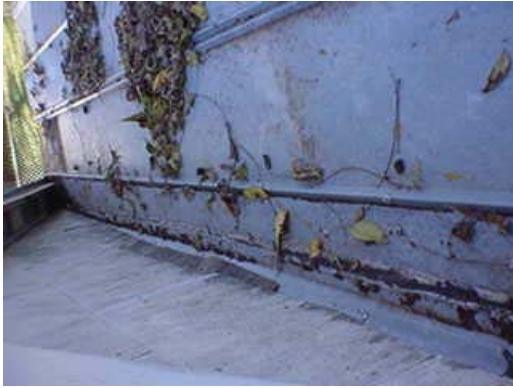
Vulnerable area where flat roof meets gable area.

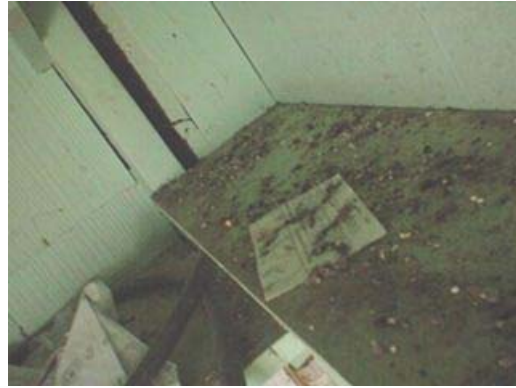
Vermin and rodent activity noted.

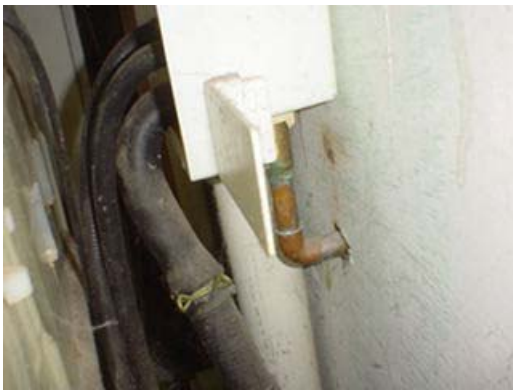
Water pipes too exterior wall should be insulated.

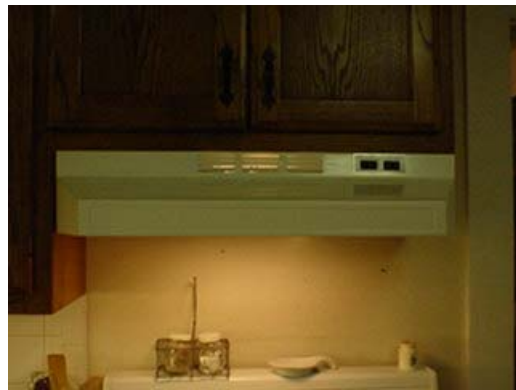
With the use of a gas stove the vent should be vented to the outside. This unit is a re-circulation vent hood.

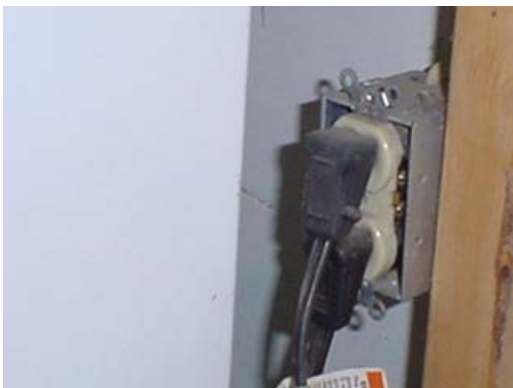
Electrical receptacle cover missing.

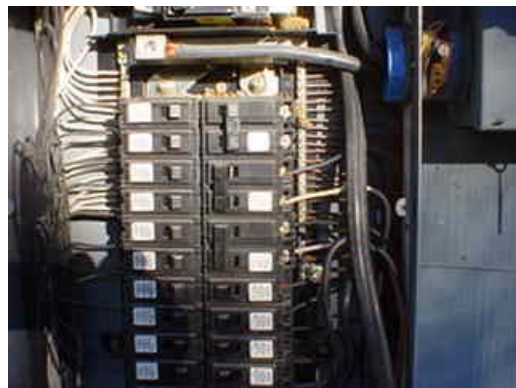
FYI - Breaker for electric stove not in use, wiring abandoned, can be reconnected for future use if desired.

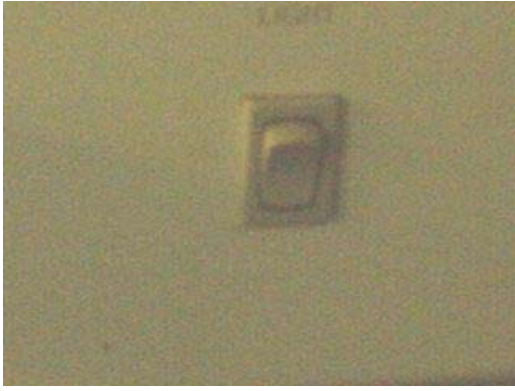
Oven light not working

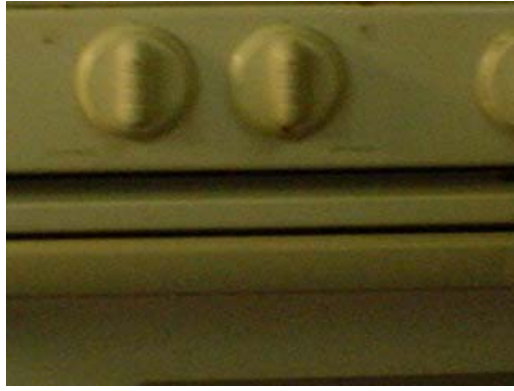
Oven does not light as intended - needs repair.

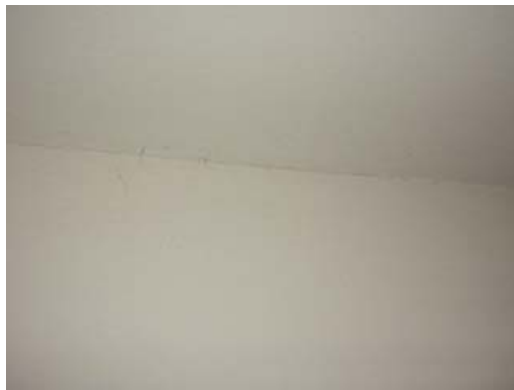
Small cracking observed where wall and ceiling meet - master bedroom.

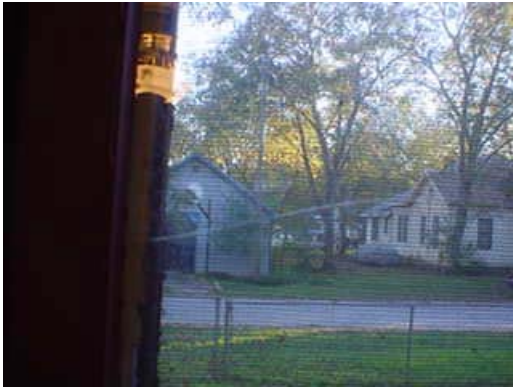
The window(s) are cracked in various locations and should be repaired.
(See Picture Page)

Cracked windows in various locations

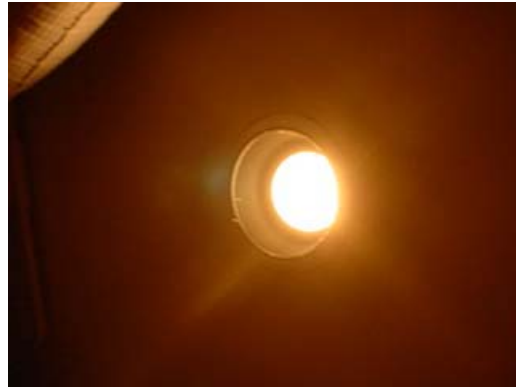
Recessed light rating?

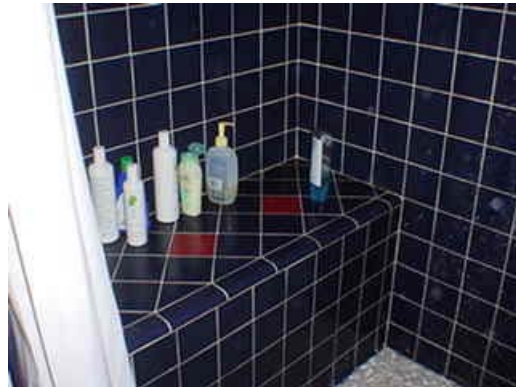
Shower stall seating area vulnerable to leaks, Monitor this area and re-grout and re-caulk as needed.

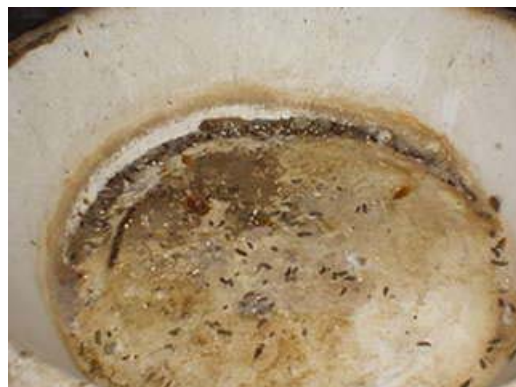
Bowl located in attic / collecting water from roof leaks and/or vermin water bowl.

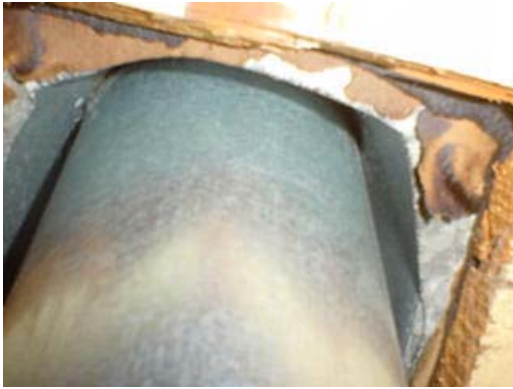
Note paper that shows burn marks from heater flue vent.

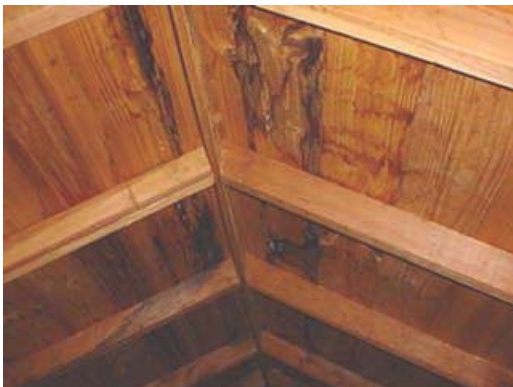
Ridge board considered being of insufficient size.

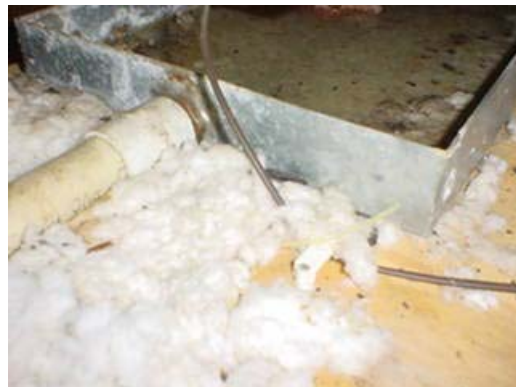
Standing water in overflow pan should be further investigated/ possible clogged main drain
